1	Product Description	Parts of outdoor furniture
Product Photo

1. Neutral salt spray (NSS) 5% for 12hrs test according to ISO 9227:2017

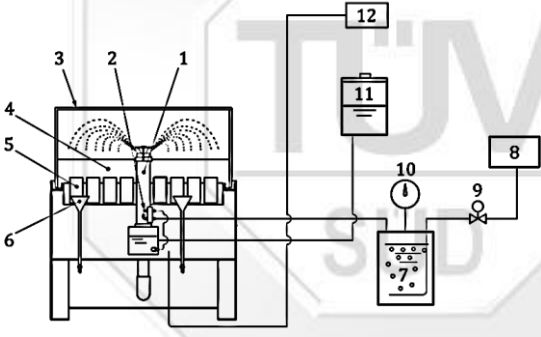
Item	Requirement-test item	Result, Remark	Evaluation
<p>NSS (Neutral Salt Spray) Test</p>	<p>An apparatuses shown below shall be used. The test sample shall be placed in the cabinet so they are not in the direct line of travel of the spray from the atomizer.</p> <p>Test condition : Chamber temperature : 35 °C ± 2 °C Average collection rate for a horizontal collecting area of 80 cm² : 1,5 ml/h ± 0,5 ml/h Concentration of sodium chloride (collected solution) : 50 g/l ± 5 g/l NaCl pH (collected solution) : 6,5 to 7,2 Test period : 96hours</p> <p>After the test, the sample shall be evaluated by appearance.</p>

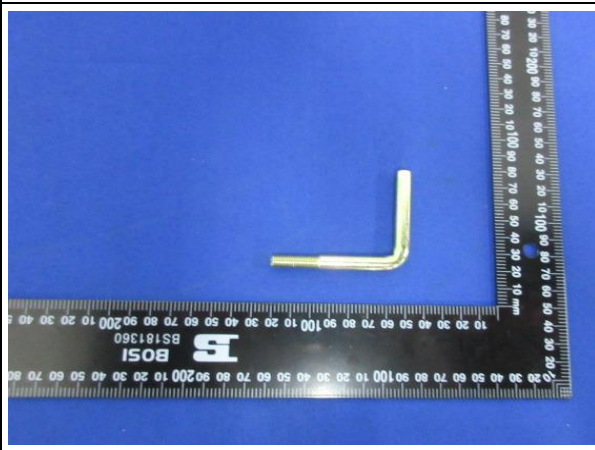
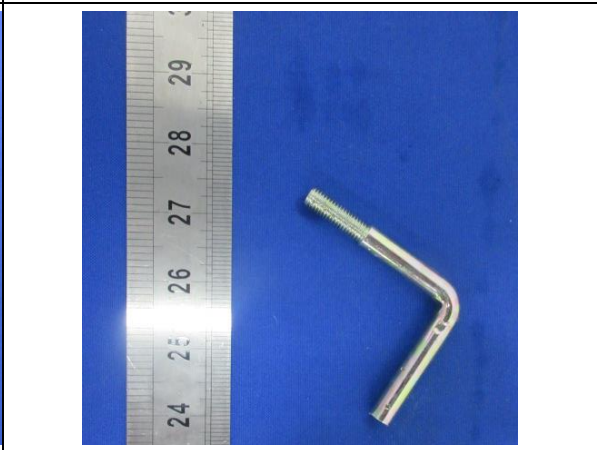
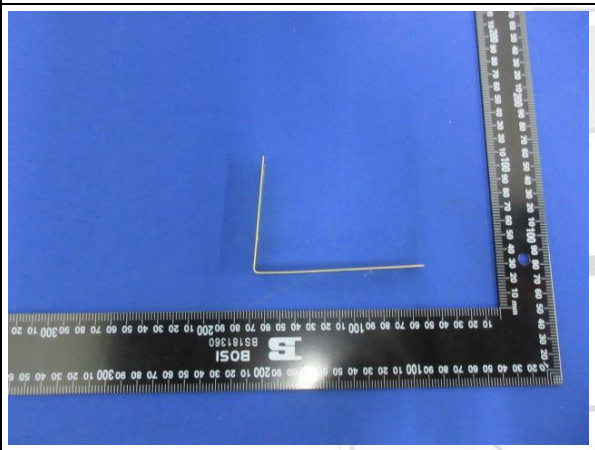
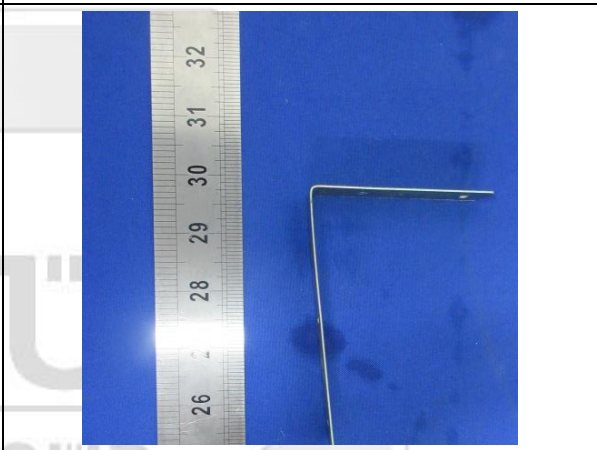
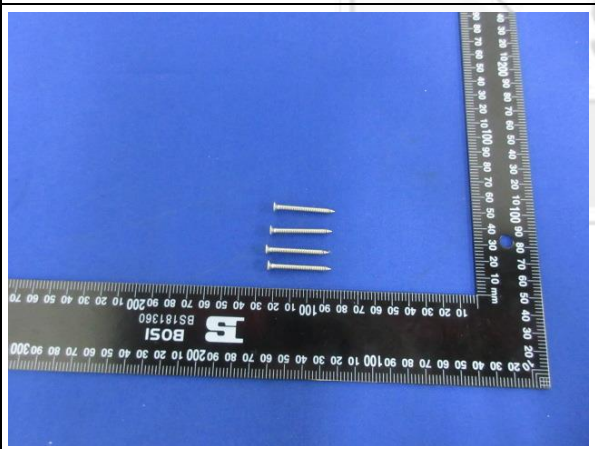
Table 1

<p>Requirements of customers is $R_A \geq 7$.</p> <p>Details see the following table and remark</p>	<p>P</p>

Before test	After test	Rating

R _A = 10
